The
Leuchter
Reports

Critical Edition

3. An Engineering Report on the Alleged Execution Gas Chambers at Auschwitz, Birkenau, and Majdanek, Poland.....	24
3.0. Introduction	24
3.1. Purpose	24
3.2. Background	25

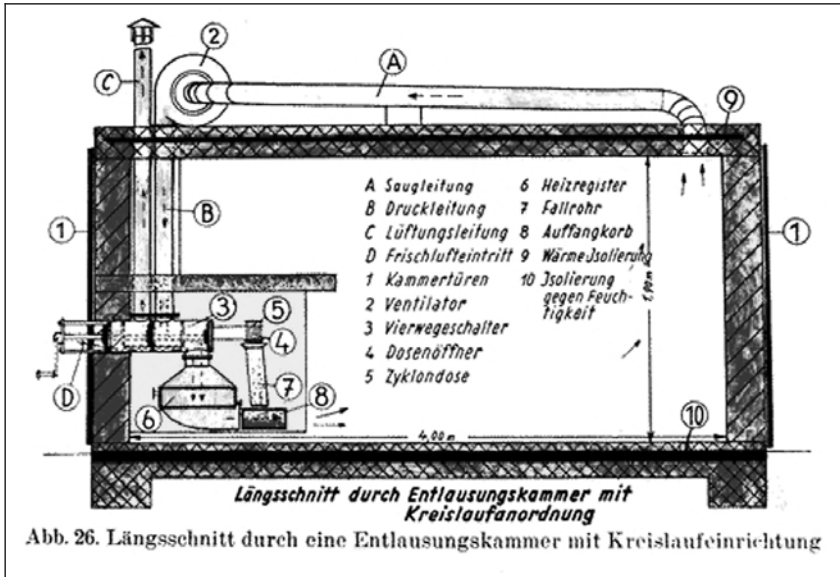
Fig. 3: DEGESCH delousing chamber with circulation feature.⁴¹ This design was developed in the late 1930s / early 1940s and became a standard in Germany during the war. It was, however, not installed in all concentration camps, which were frequently equipped with makeshift delousing chambers. Editor's note.

⁴⁷ The procedure can be vastly accelerated when using special fumigation chambers designed like the DEGESCH "Kreislaufanlage" (circulation facility), see Gerhard Peters, E. Wüstinger, "Entlausung mit Zyklon-Blausäure in Kreislauf-Begasungskammern. Sach-Entlausung in Blausäure-Kammern," *Zeitschrift für hygienische Zoologie und Schädlingsbekämpfung*, 32 (10/11) (1940), pp. 191-196; cf. also F.P. Berg, "The German Delousing Chambers," *Journal of Historical Review*, 7(1) (1986), pp. 73-94 (www.vho.org/GB/Journals/JHR/7/1/Berg73-94.html).

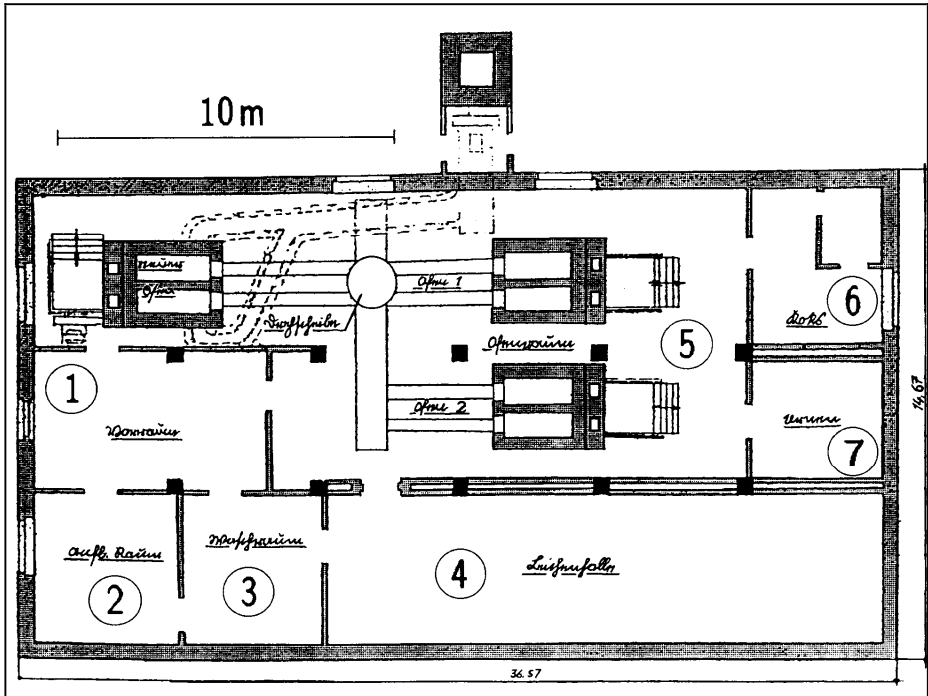
Fig. 4: Ground plan of crematorium I in Auschwitz I/main camp in its original condition. The morgue was later alleged to have been used as a 'gas chamber'.¹²⁵

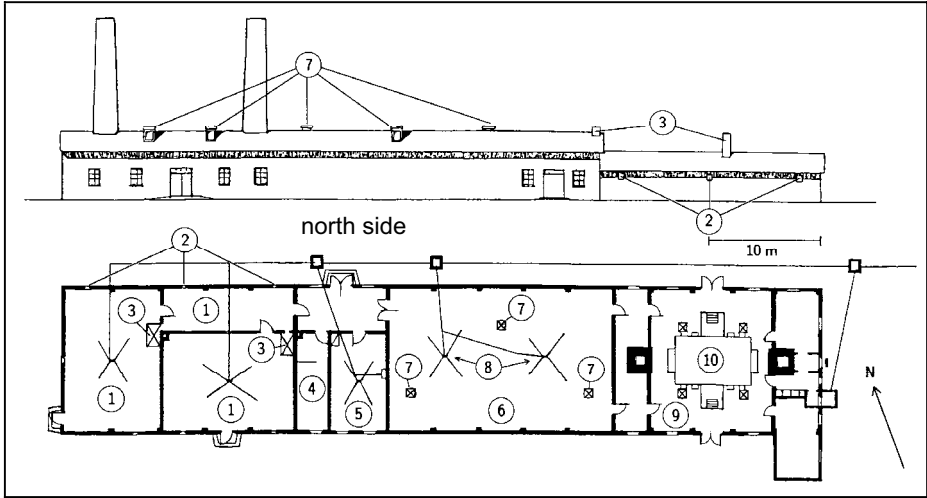
Fig. 7: North lateral view (above) and ground plan (below) of crematorium IV and/or V (mirror image) in Auschwitz II/Birkenau camp.¹⁴⁹

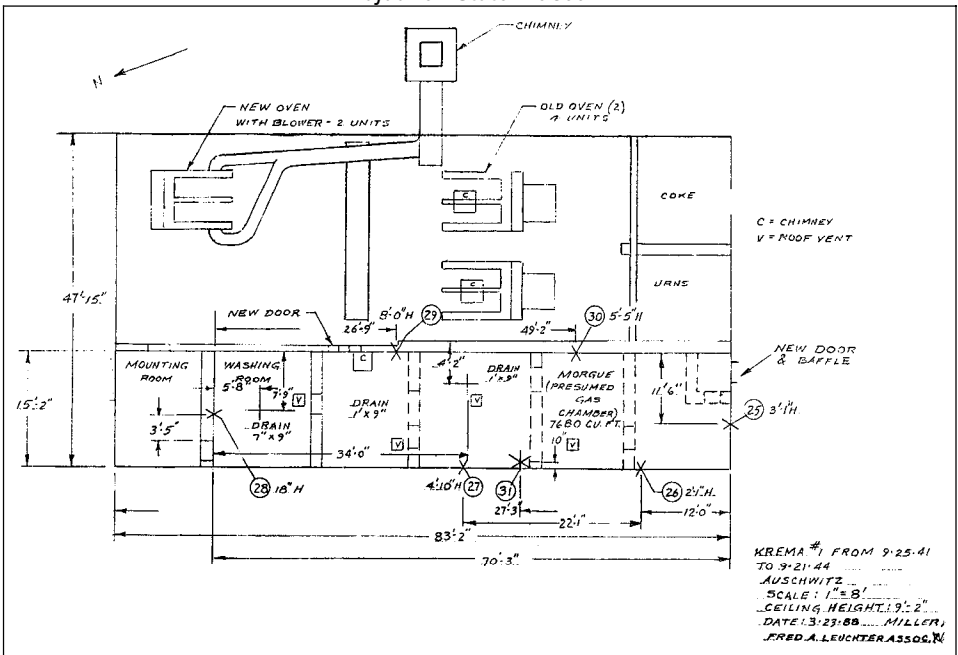
Fig. 12: Floor plan of Krematorium I in Auschwitz main camp, drawn by H. Miller, Fred A. Leuchter Associates. Numbers in circles denote locations where wall sample were taken.

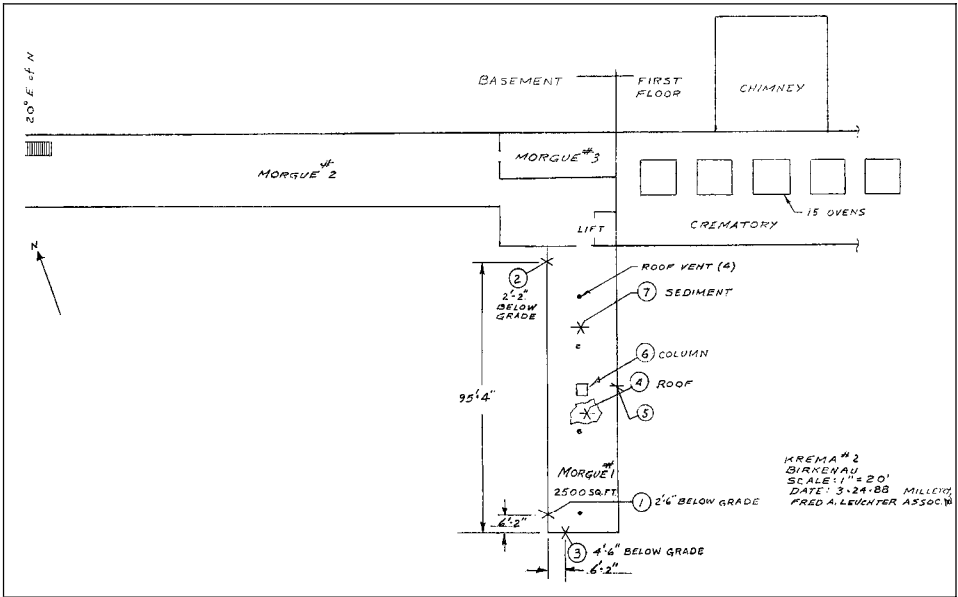
Fig. 13: Floor plan of Krematorium II in Auschwitz Birkenau, drawn by H. Miller, Fred A. Leuchter Associates. Numbers in circles denote locations where wall sample were taken. Note: The "Roof Vent (4)" do not exist; see document on next page.

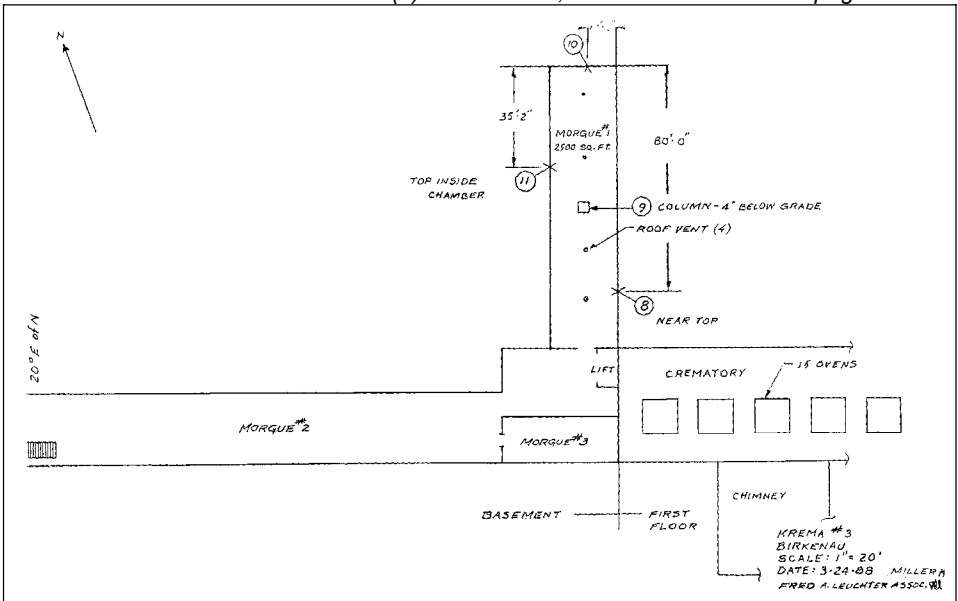
Fig. 14: Floor plan of Krematorium III in Auschwitz Birkenau, drawn by H. Miller, Fred A. Leuchter Associates. Numbers in circles denote locations where wall sample were taken. Note: The "Roof Vent (4)" do not exist; see document on next page.

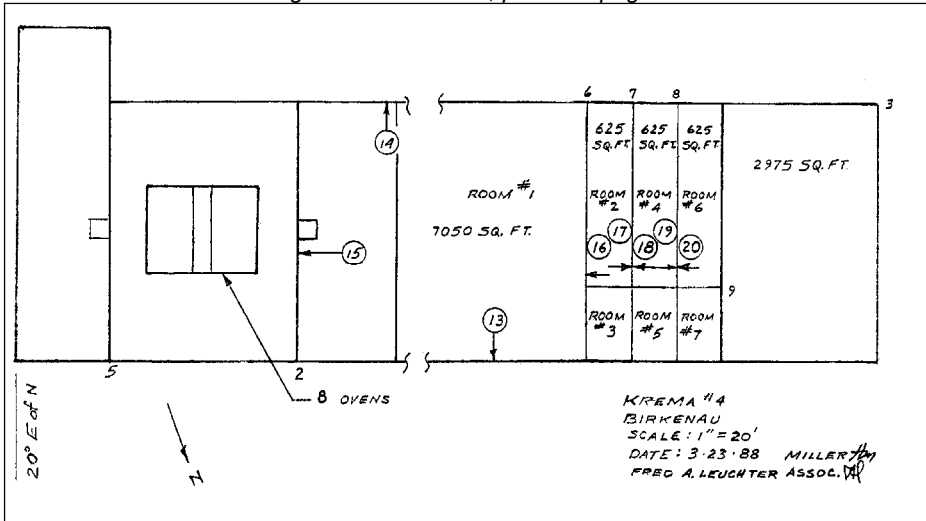
Fig. 16: Floor plan of Krematorium IV in Auschwitz Birkenau, drawn by H. Miller, Fred A. Leuchter Associates. Numbers in circles denote locations where wall sample were taken.

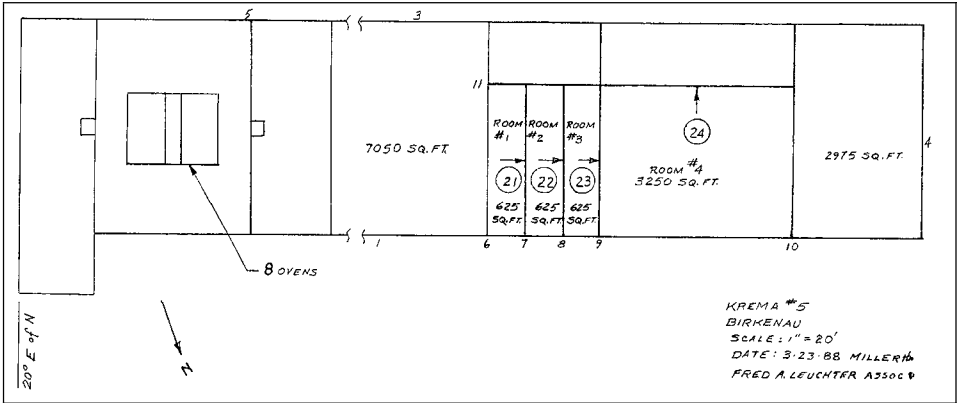
Fig. 17: Floor plan of Krematorium V in Auschwitz Birkenau, drawn by H. Miller, Fred A. Leuchter Associates. Numbers in circles denote locations where wall sample were taken.

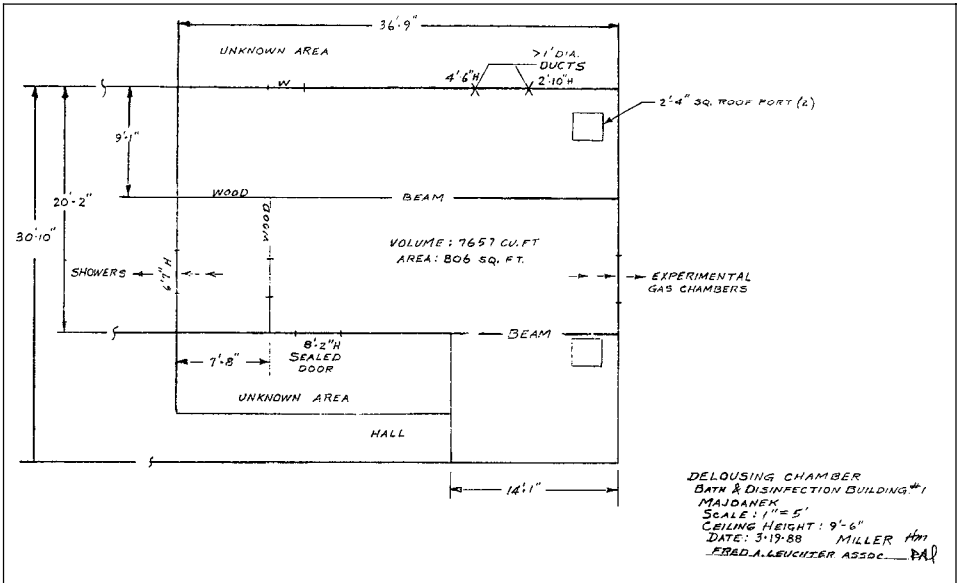
Fig. 18: Floor plan of Bath & Disinfection Building #1 at the Majdanek camp, drawn by H. Miller, Fred A. Leuchter Associates.

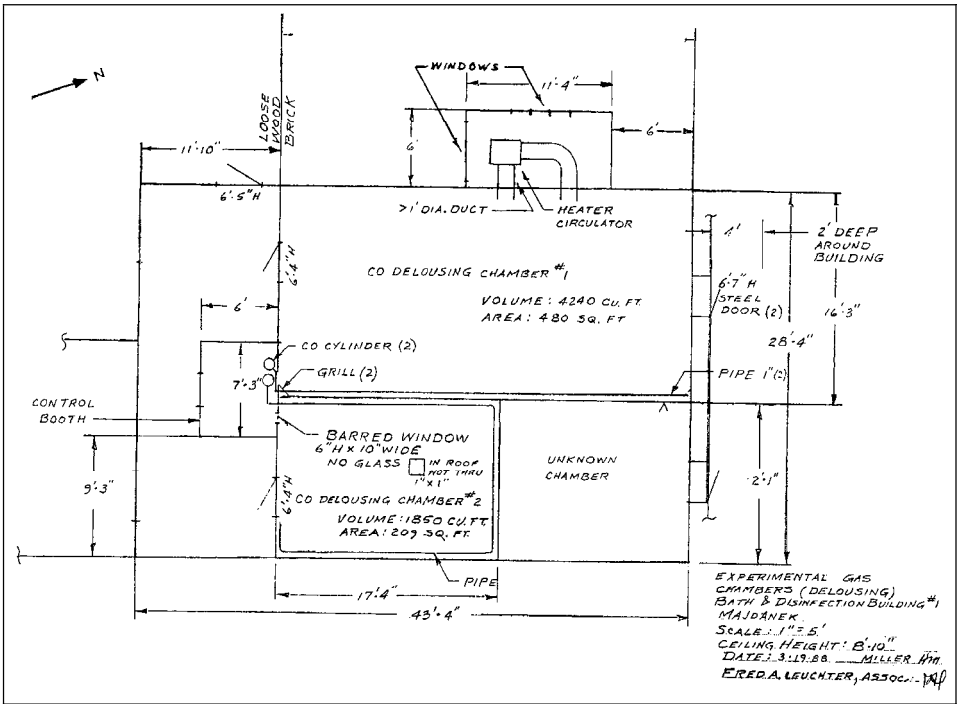
Fig. 19: Floor plan of the delousing wing of Bath & Disinfection Building #1 at the Madjanek camp, drawn by H. Miller, Fred A. Leuchter Associates.

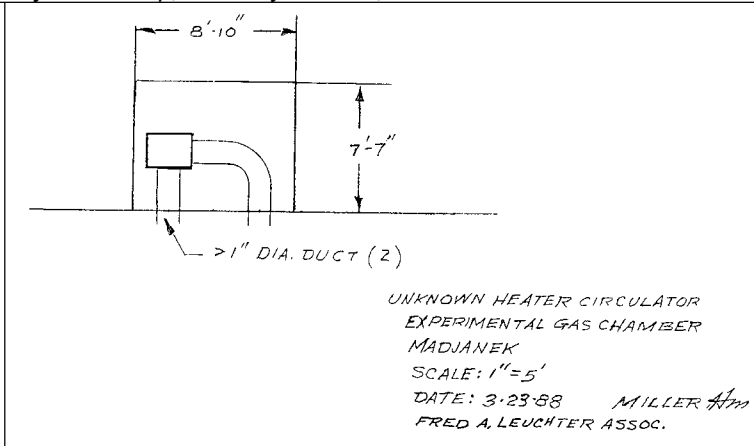
Fig. 20: Sketch of Heater Circulator of delousing chamber in previous document, drawn by H. Miller, Fred A. Leuchter Associates.

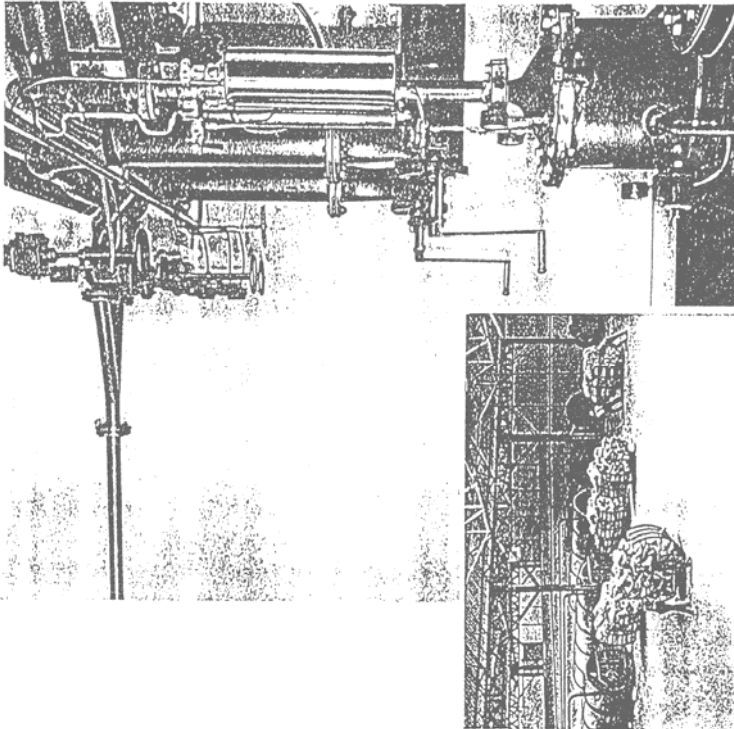
Two ZYKLON vaporizers with special fin openers and a vaporizer for liquid hydrocyanic acid in the generator room of the vacuum fumigation plant, Port of Casablanca.

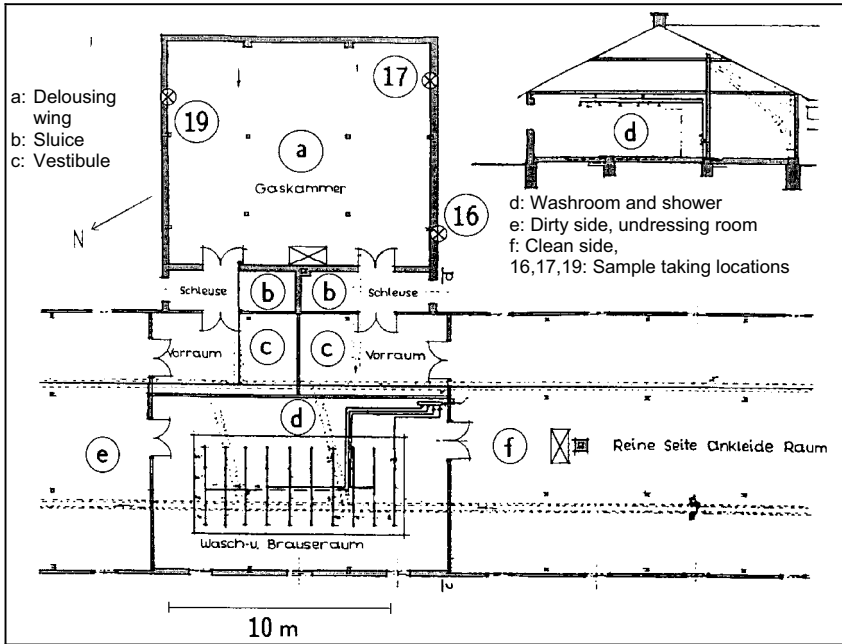
Fig. 23: Ground plan of the HCN disinfestation wing of building 5a before building alterations (mirror image) and BW 5b today. BW 5b sample taking locations for the Rudolf Report drawn in.¹⁷⁴

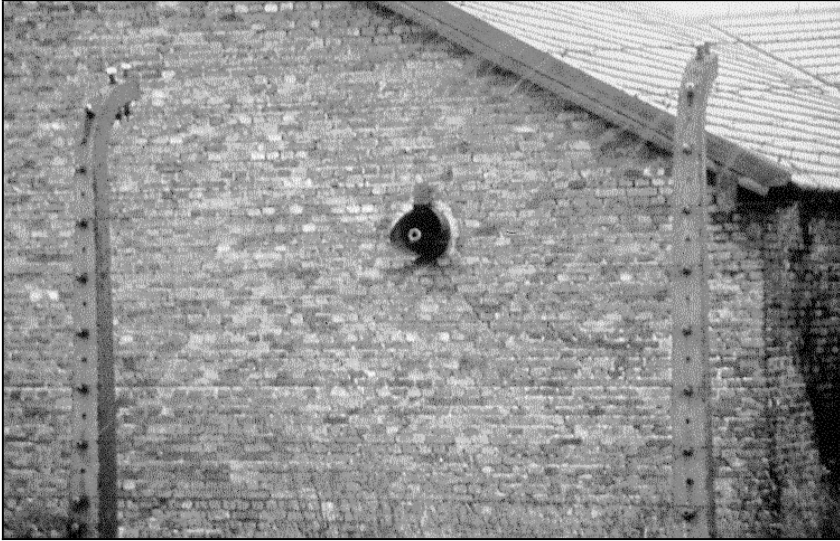
Fig. 24: One of the two ventilation outlets from the disinfestation wing of building BW 5b, without equipment today. The other is located on the same wall slightly to the left. The end of a water pipe put in there after the war is visible.

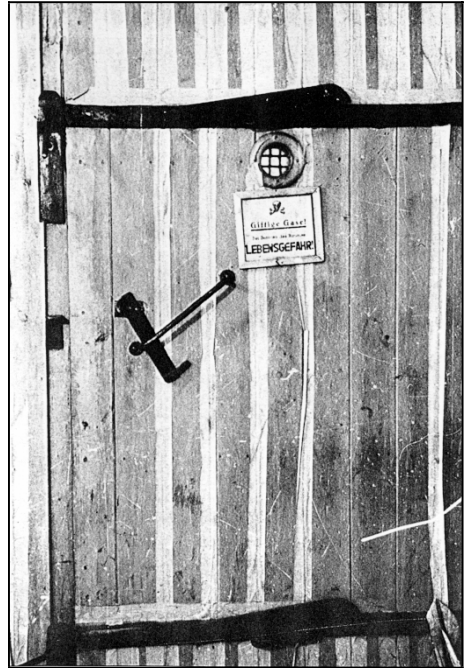
Fig. 25: *Wooden disinfestation chamber door at Auschwitz rendered provisionally gas-tight with peephole and metal protection grid. This is what the gas-tight doors for the homicidal ‘gas chambers’ are supposed to have looked like. Note the extremely flimsy lock.¹⁷⁷*

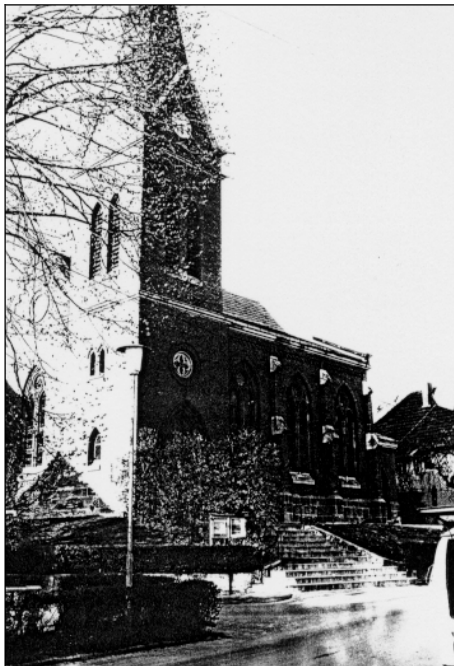
Fig. 36: In August 1976, the Protestant church at D-96484 Meeder-Wiesefeld was fumigated with Zyklon B. Subsequently, blue-colored stains appeared all over the plaster (see Fig. 37).

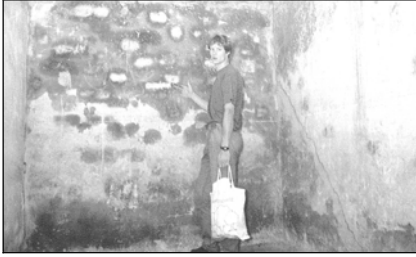
Fig. 38: Blue staining of the Interior northwest room in the Zyklon B disinfestation wing of BW 5a in the Birkenau camp. (© Karl Philipp²⁰¹)

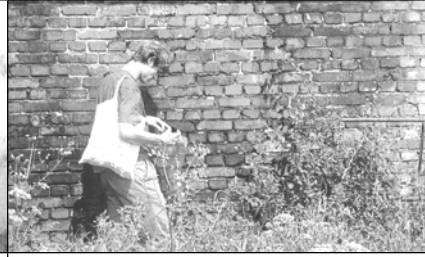
Fig. 39: Blue staining of the exterior southwest wall of the Zyklon B disinfestation wing of BW 5b in the Birkenau camp. (© Karl Philipp²⁰¹)

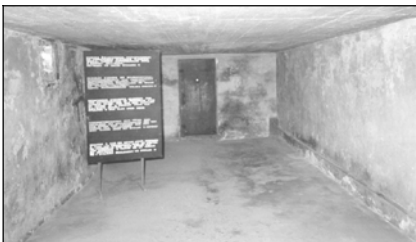
Fig. 40: Blue staining of the Zyklon B disinfestation installation, chamber III, of barrack 41 in Majdanek camp. (© C. Mattogno²⁰²)

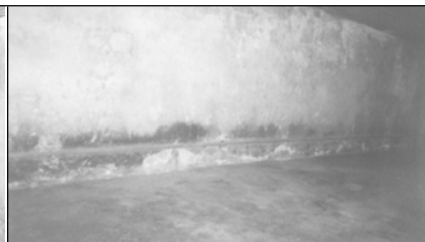
Fig. 41: Blue staining of the Zyklon B disinfestation installation, east wall of chamber III of barrack 41 in Majdanek camp. (© C. Mattogno²⁰²)

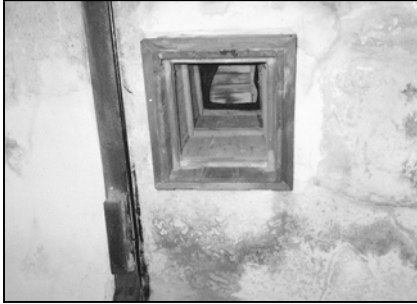
Fig. 42: Blue staining of the large Zyklon B disinfestation chamber, ceiling, barrack 41 in Majdanek camp. (© C. Mattogno²⁰²)

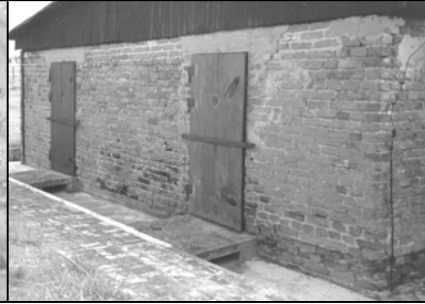
Fig. 43: Blue staining of the Zyklon B disinfestation installation, chambers II and III (exterior wall), of barrack 41 in Majdanek camp. (© Carlo Mattogno²⁰³)

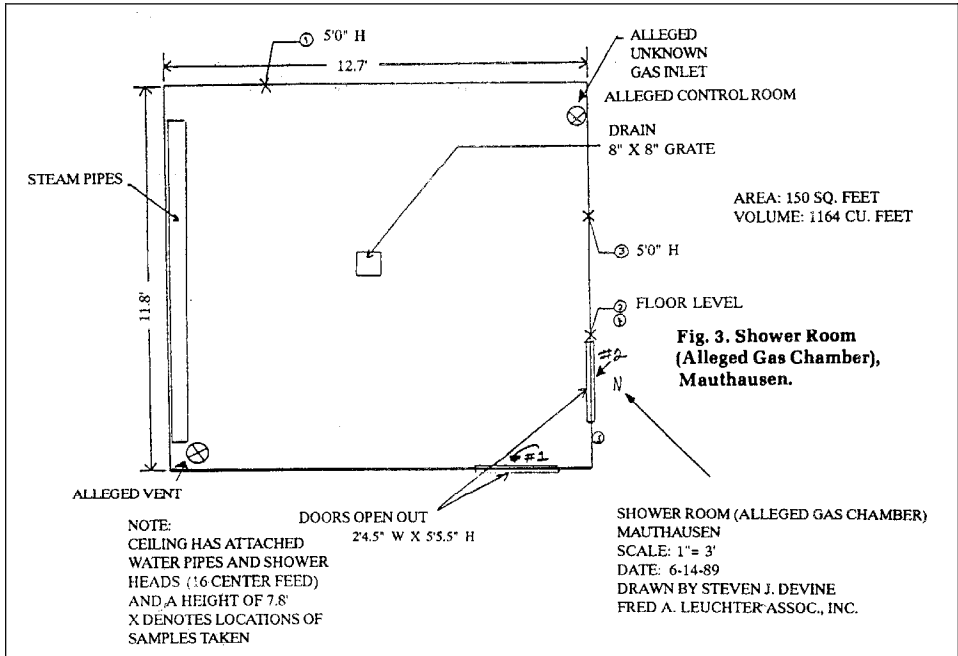
Fig. 49: Floor Plan of the shower (alleged gas chamber) at Mauthausen camp, Austria. Encircled X denote locations of wall samples taken.

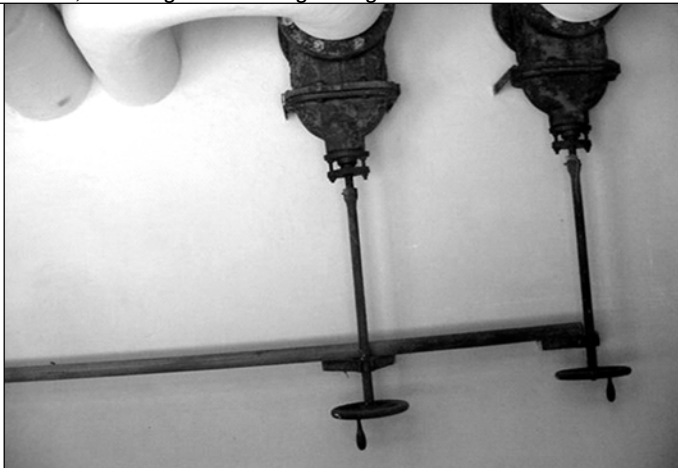
Fig. 51: Heavy insulated hot water (or steam?) pipes in the room behind the alleged gas chamber of Dachau camp, leading into the space above the current room.¹

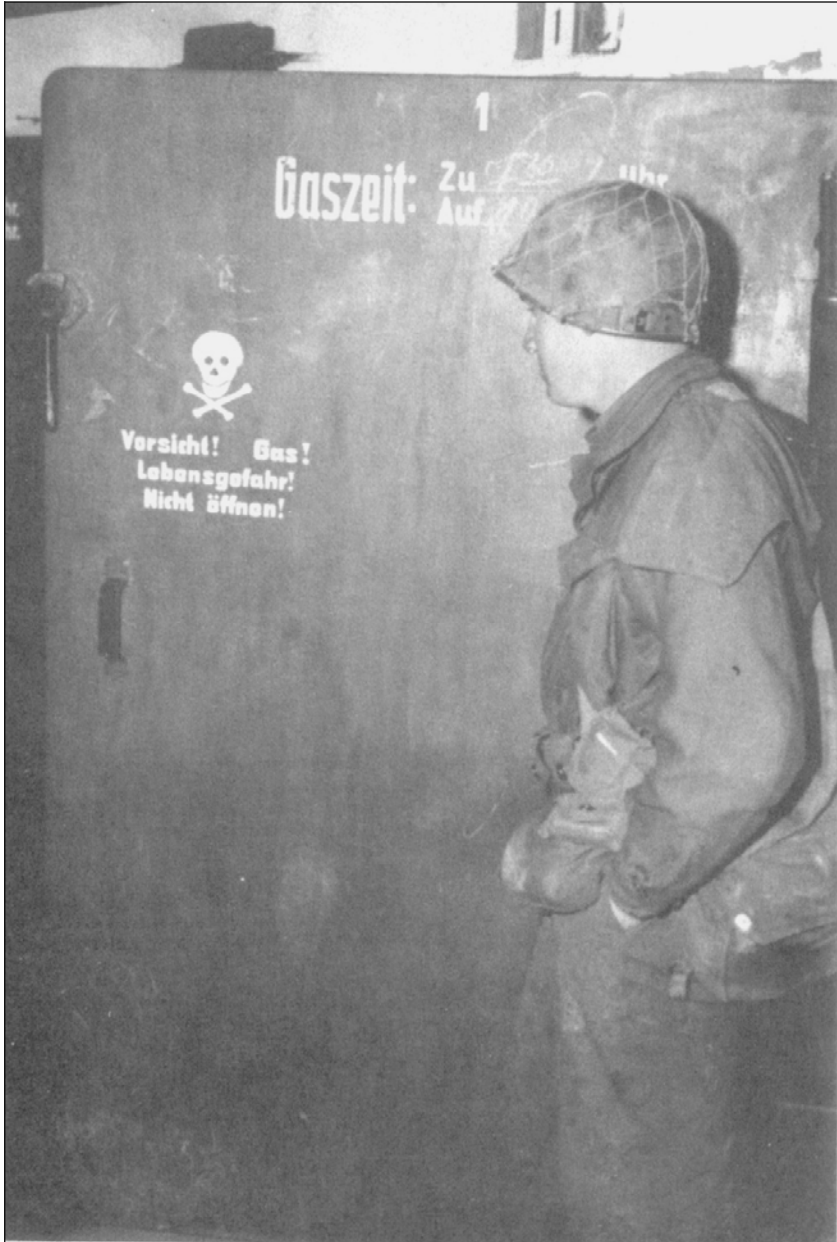
Fig. 52: Door of disinfestation chamber at Dachau. The inscriptions on the door specify that the chamber was last used from 7:30 to 10 in the morning. The warning reads "Caution! Gas! Life danger! Do not open!" The U.S. Army caption for this photograph declares deceptively: "Gas chambers, conveniently located to the crematory, are examined by a soldier of the U.S. Seventh Army. These chambers were used by Nazi guards for killing prisoners of the infamous Dachau concentration camp."¹²

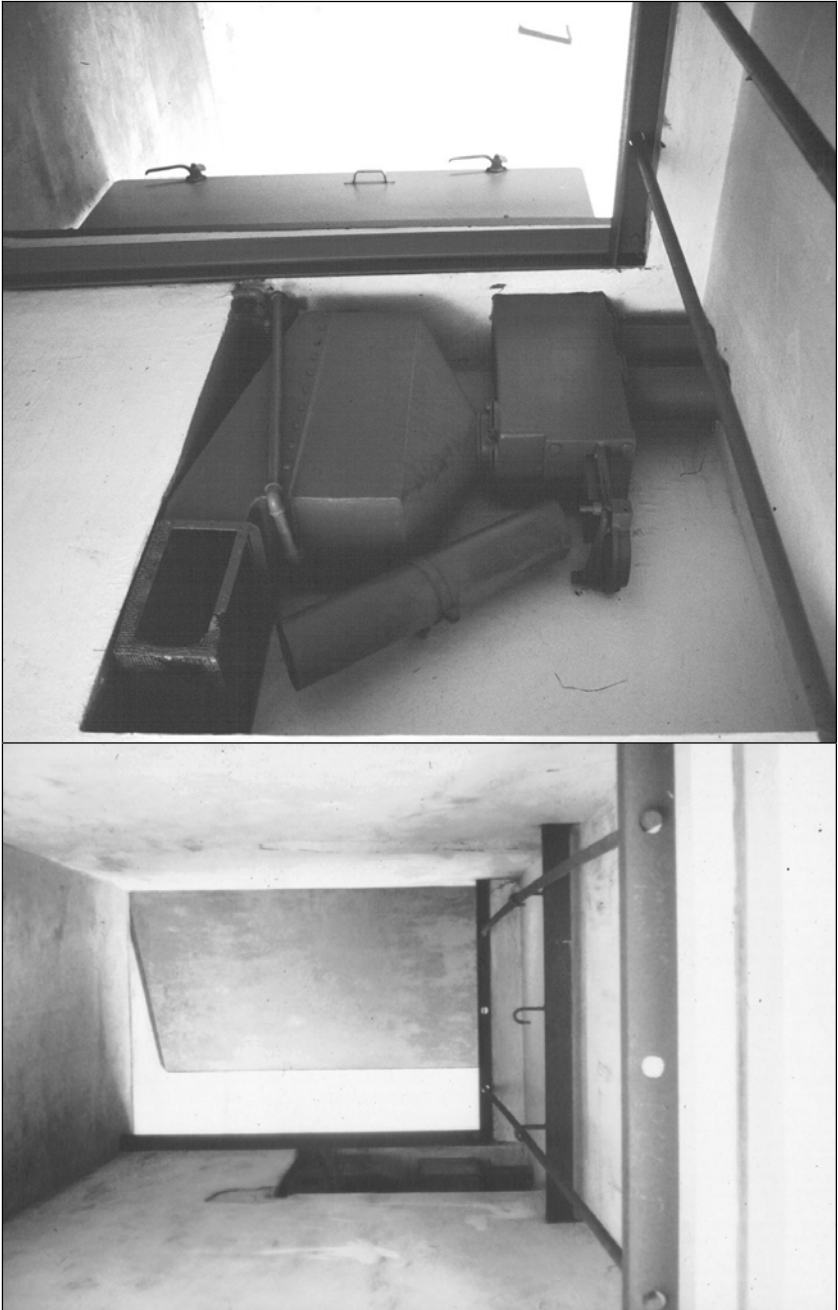
Fig. 57 & 58: Interior of disinfestation chamber at Dachau; left: DEGESCH Kreislaufanlage (circulation device); right: look through the chamber.⁵

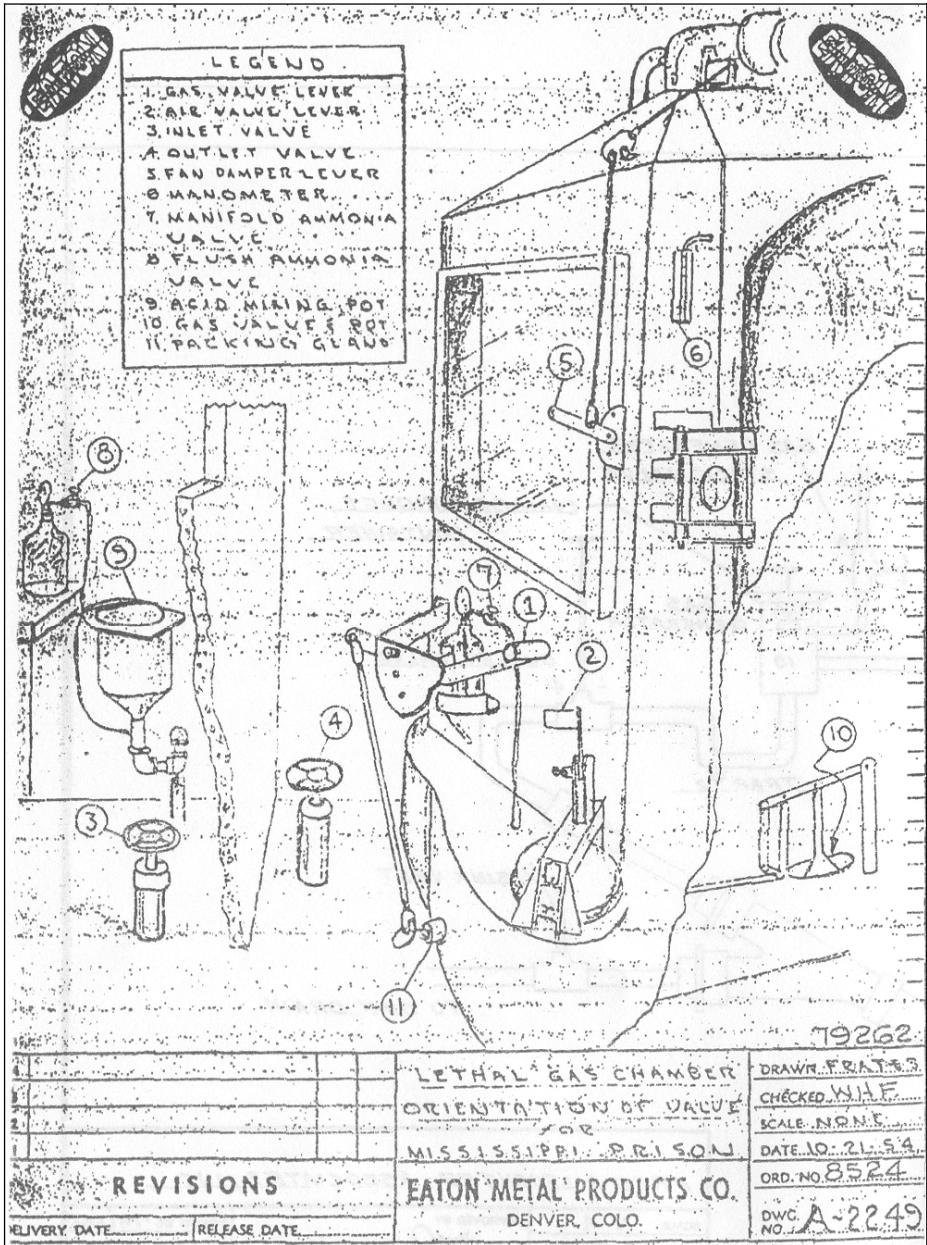
Fig. 66: Eaton Proposal for the lethal gas chamber at the Mississippi State Penitentiary at Parchman, MS, of 1954. Courtesy to the Mississippi Department of Corrections.

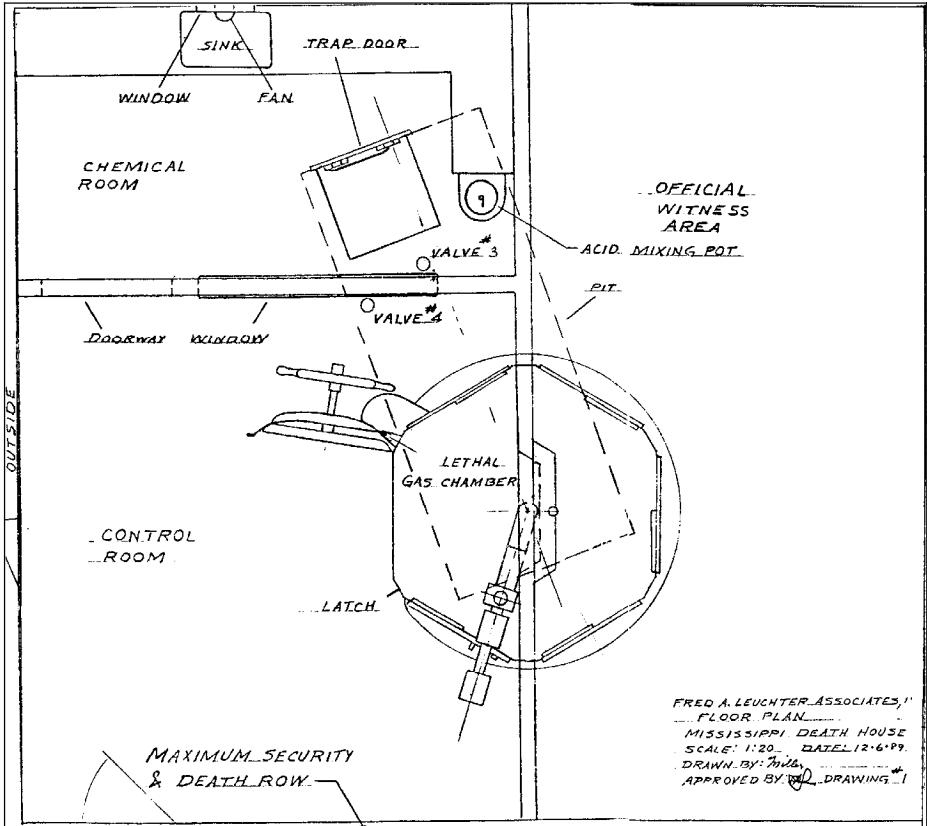
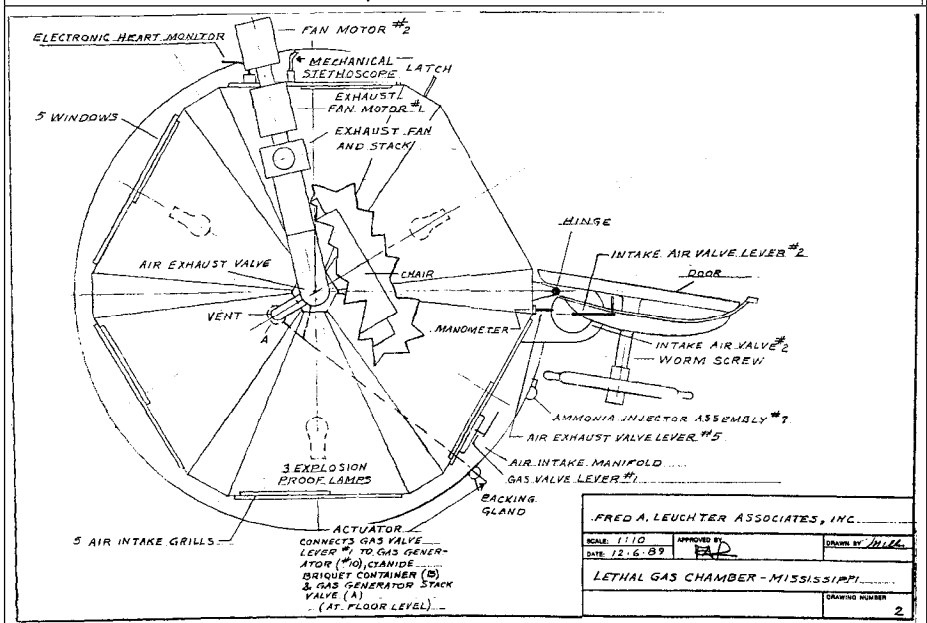
Fig 69 & 70: Technical drawings of the Parchman (MS) execution gas chamber.

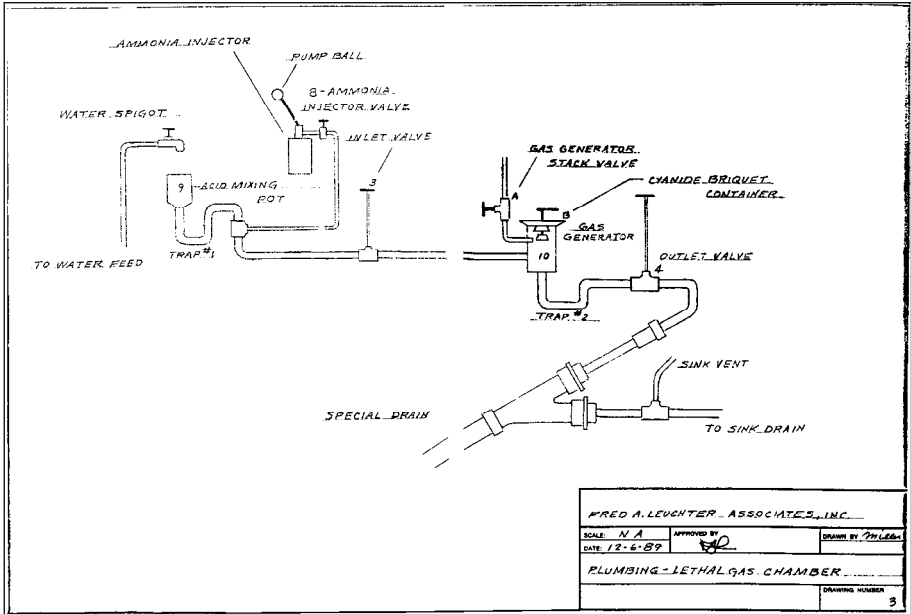
Fig 71: Technical drawing of gas generator of the Parchman (MS) execution gas chamber.

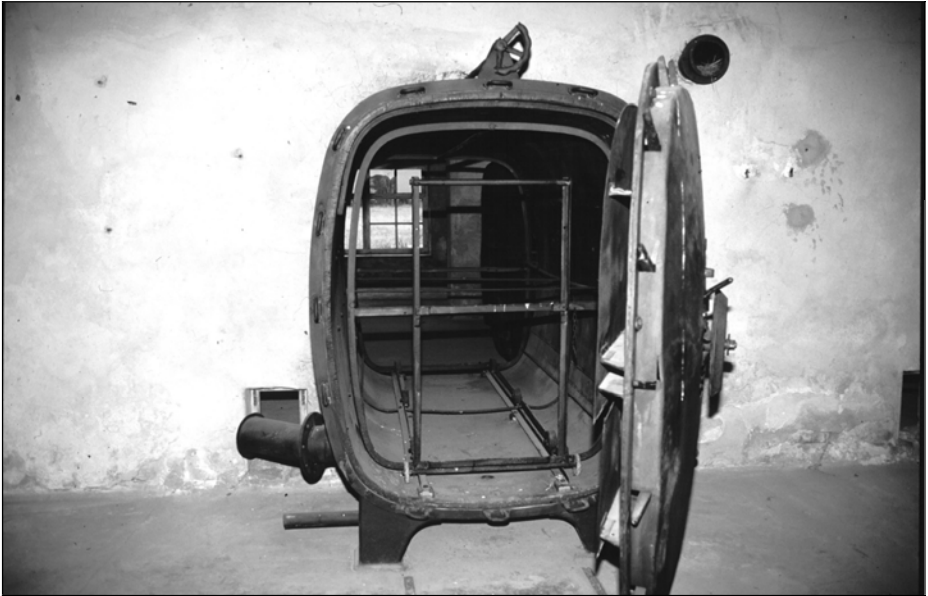
Fig. 78: Hot air disinfestation autoclave in the so-called “Zentralsauna” in Auschwitz Birkenau with similar doors as used for the U.S. execution gas chambers. Although the German camp authorities had the technology required for constructing execution gas chambers, they did not use it. They used this technology to save the lives of their prisoners instead.

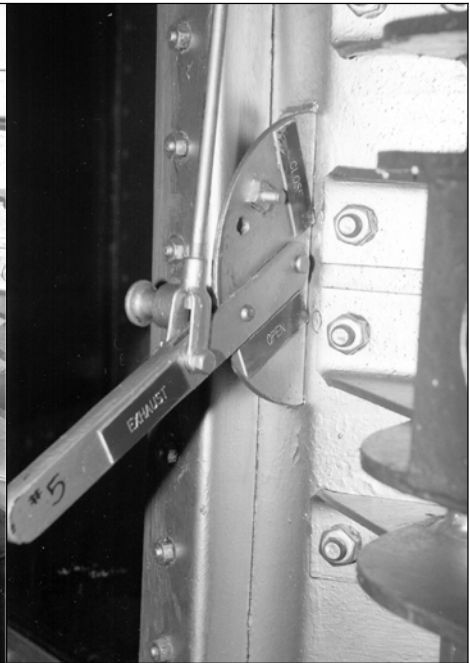
Fig. 85: Closeup of lever used to open and close exhaust stack.

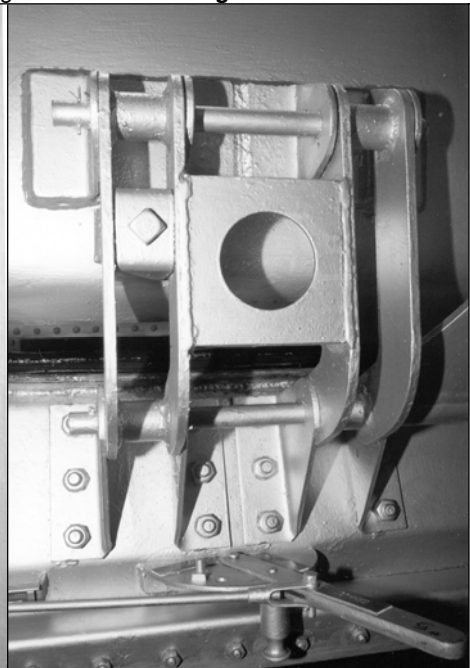
Fig. 91: Closeup of gas chamber door hinge.

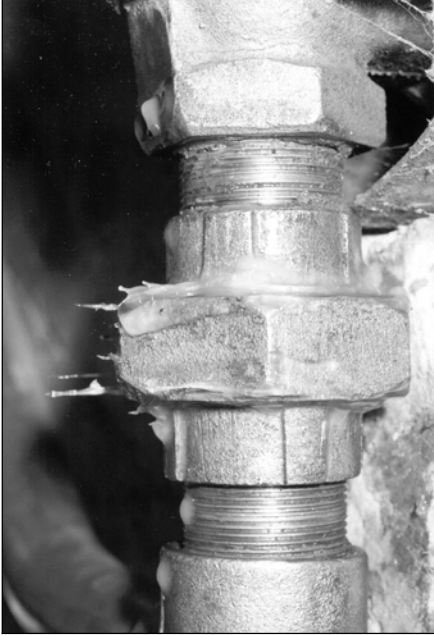
Fig. 92: Closeup of plumbing underneath the gas chamber covered in vaseline to indicate leaks.

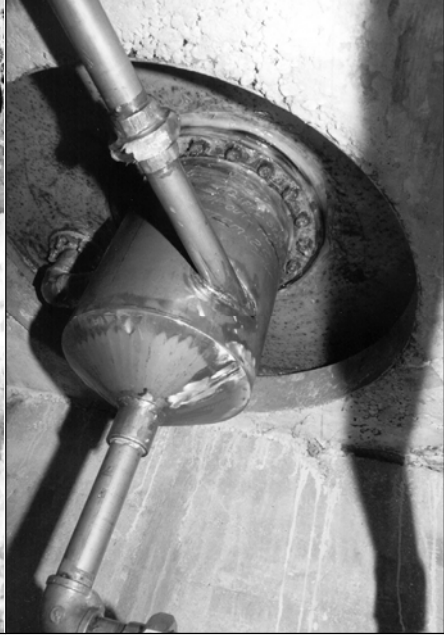
Fig. 93: View of stainless steel plumbing and chemical container directly under seat in gas chamber.

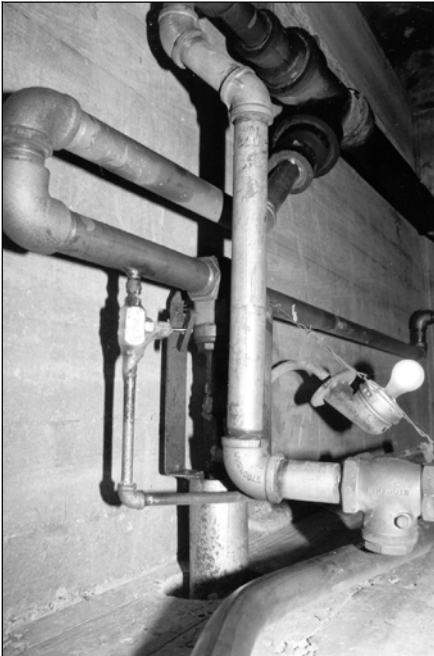
Fig. 94: Portion of plumbing and sewage system connecting chemical room to gas chamber.

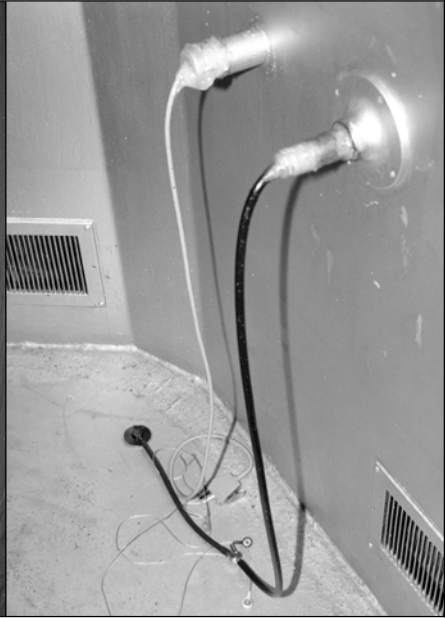
Fig. 97: Inside gas chamber where stethoscope and other body monitoring line enter. They are covered in vaseline to indicate leaks. Fresh air vents on the walls close to the floor.

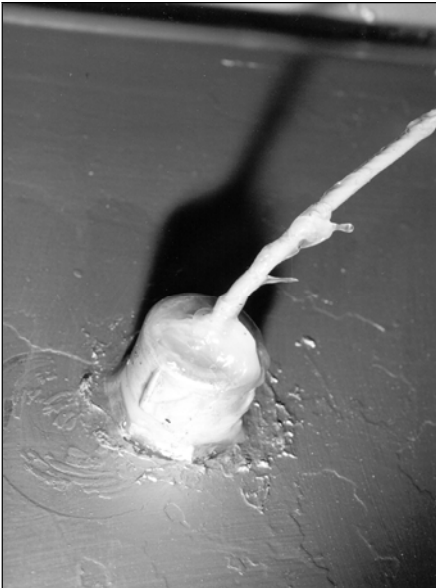
Fig. 98: Closeup of where monitoring line enters chamber also coated in vaseline.
